ALTERNATIVE STOCK WATERING SYSTEMS

FINAL REPORT

A WATER QUALITY/QUANTITY IMPROVEMENT PROGRAM

Submitted by:
Siskiyou Resource Conservation District
Gary Black
Missey Dunaetz
PO Box 268
Etna, CA 96027

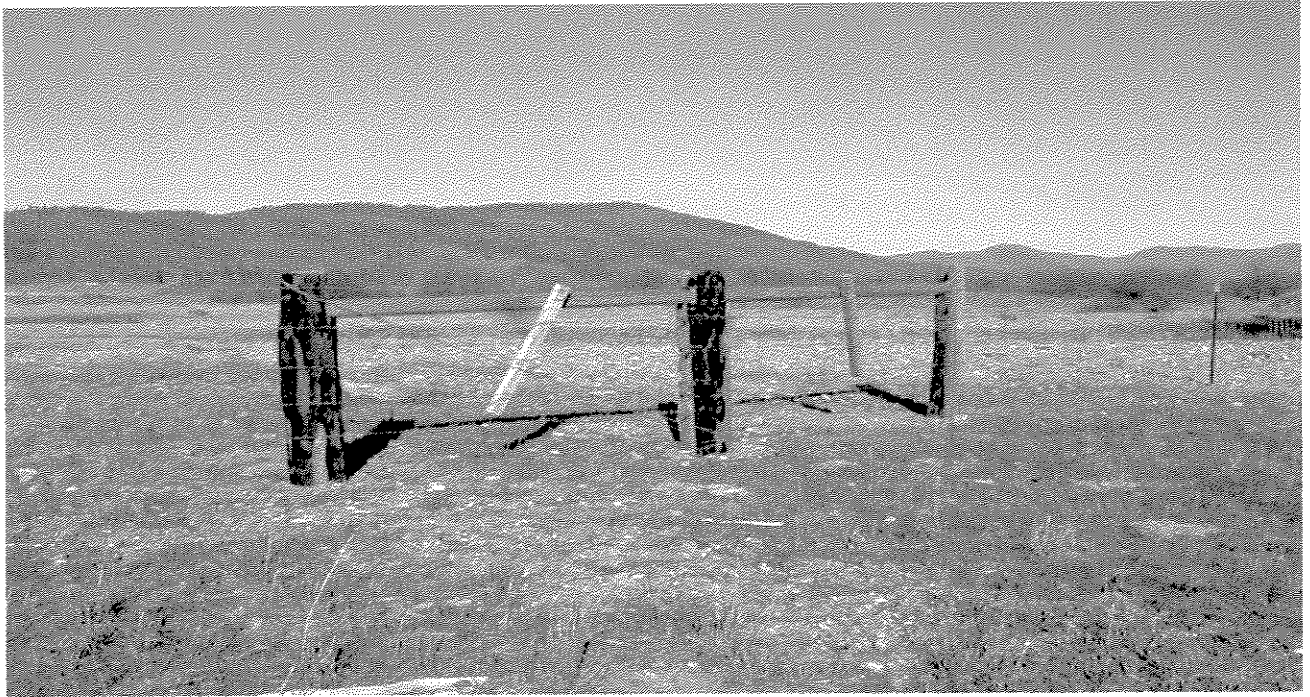
Wood bracing along Lower Kidder Creek

Approximately 4500' of riparian fencing has been installed along the lower portion of Kidder Creek near the confluence with the Big Slough. The fencing was installed to protect the riparian area in order to improve riparian and channel conditions along Kidder Creek. Natural regeneration has been limited by uncontrolled grazing. The lack of riparian root strength and increased bed load has allowed the channel of Kidder Creek to become unstable, excessively wide and flat. Riparian fencing was proposed for the area to eliminate future damage caused by livestock and allow natural revegetation to occur. There are positive signs throughout the riparian area that natural revegetation will occur rapidly. The riparian area ranges in width from 150' to over 500'.

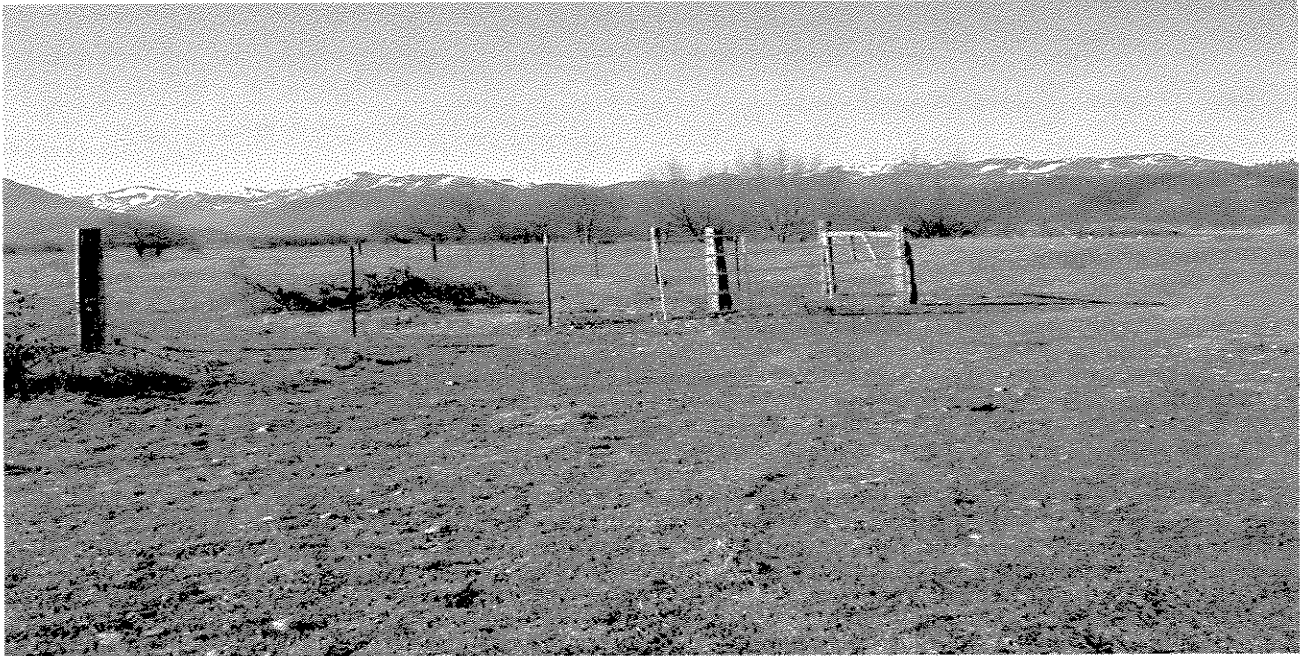
Gates at crossing on Lower Kidder Creek

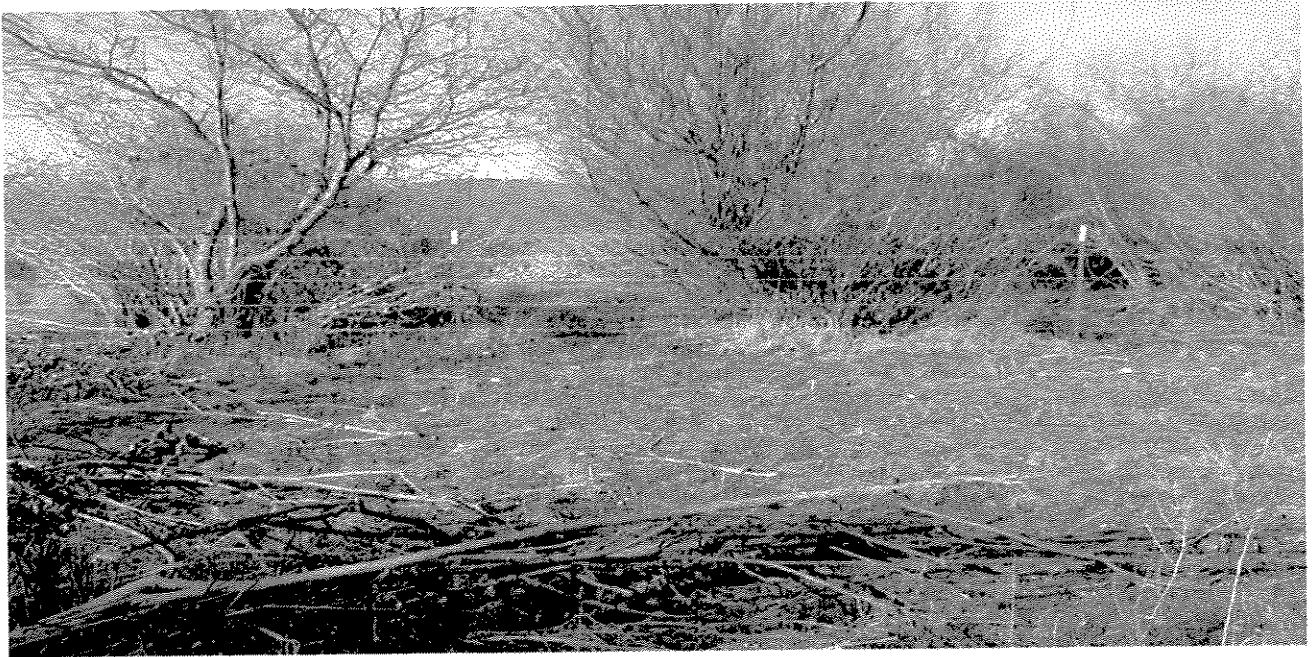
Fence line constructed along Lower Kidder Creek

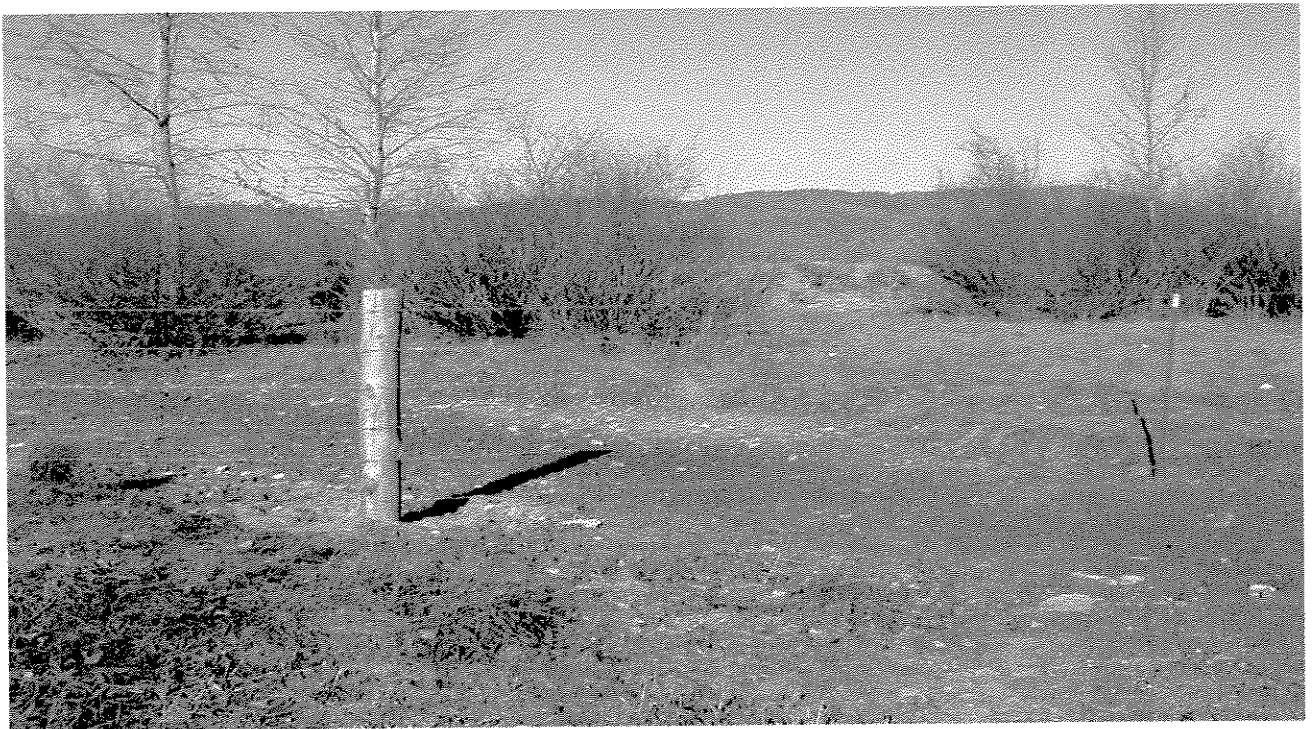
Wooden posts used along Lower Kidder Creek

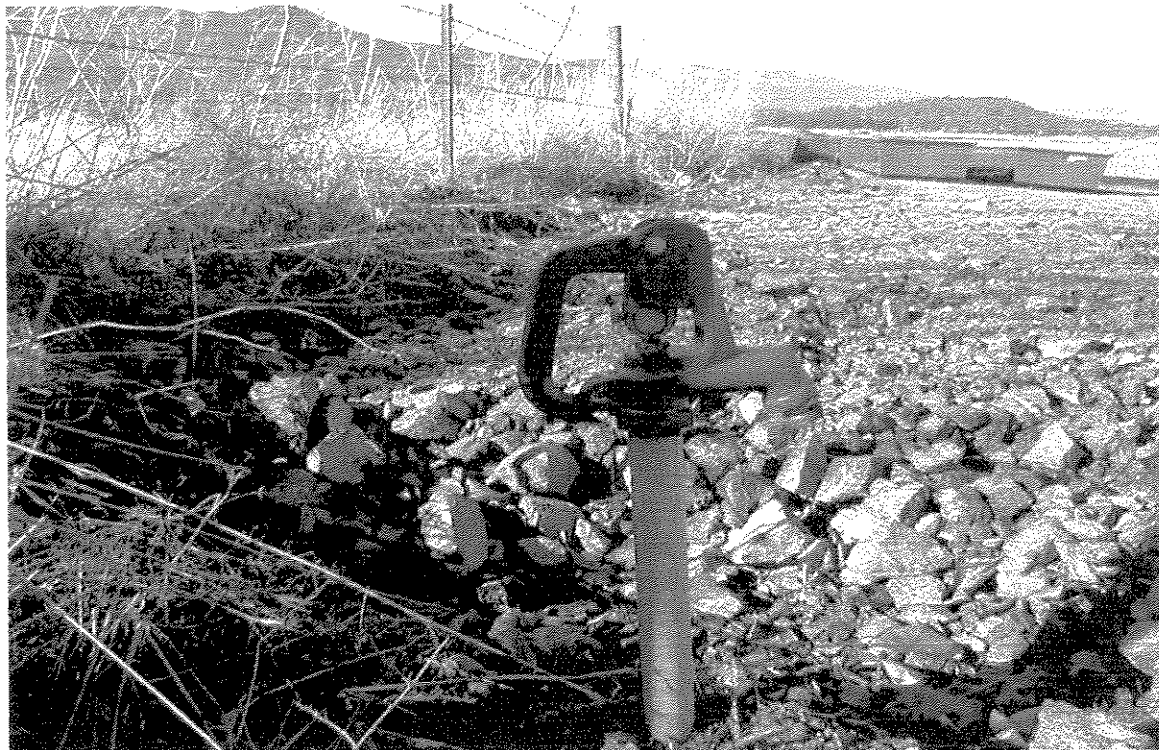
Frost free hydrant for stock watering system on Scott River near Horn Lane Bridge.

Troughs are also supplied by the RCD. The number of troughs and size depends on the number of livestock using the system and the management style related to cost/ benefit. The flow to the troughs is activated by a float valve which conserves water and power by eliminating the need for continuous flow. Frost free hydrants are used to reduce the chance of frozen pipes during winter weather.

Stock Watering Projects completed with this funding include a project that provided fencing and a stock watering system that affected the main stem of the Scott River from Horn Lane North to Young's point. We provided a stock watering system in order to eliminate the need for livestock to enter the riparian area. We varied from the typically used pump by experimenting with a 2 horsepower variable speed pump which eliminated the necessity of the pump house, concrete foundation and pressure tank. Over 4000' of 1" and 1 1/4" diameter PVC pipe was buried 30"-36" deep in the soil to connect the pump to the troughs. Three (3) troughs were purchased to keep approximately 200 head of cattle out of the riparian area. The project eliminated the need for livestock to enter the riparian area and also will act as a watering source for riparian plantings (Scott River Riparian Planting Project II).

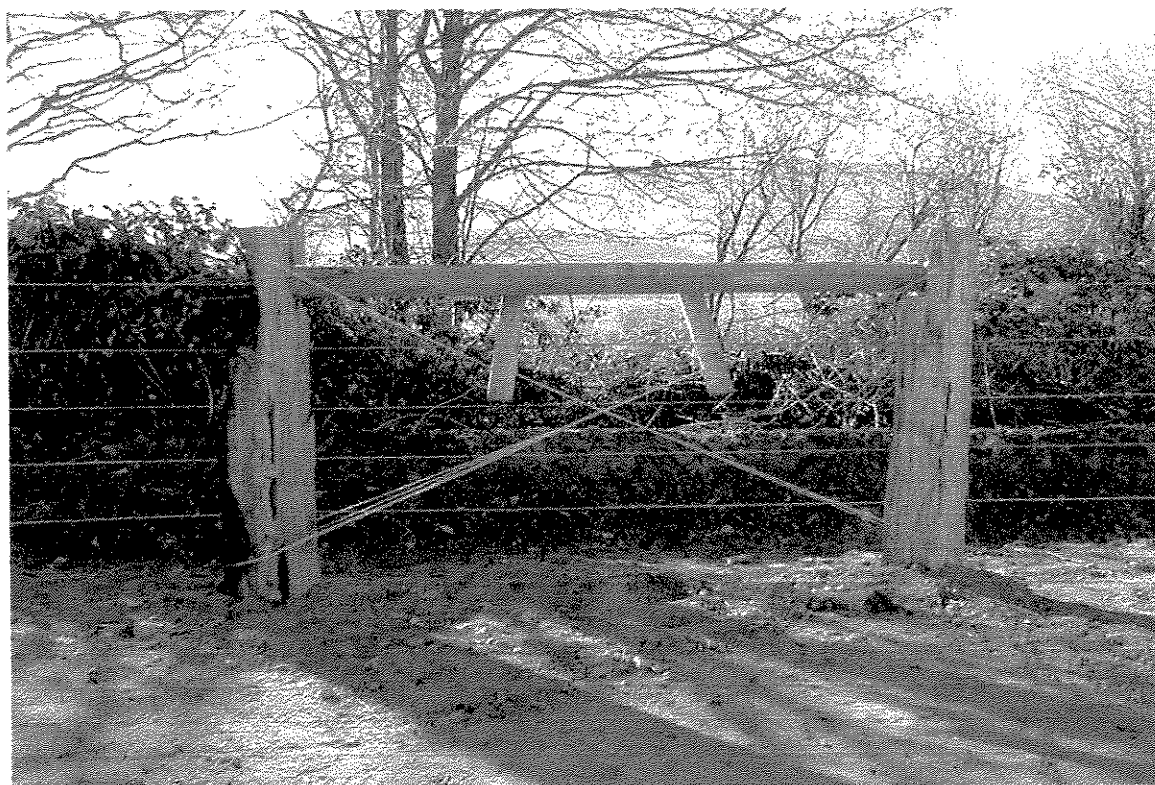
Cedar bracings on livestock fence – Scott River near Horn Lane Bridge.

An additional 2000' of fencing was constructed along the Scott River above the Horn Lane Bridge. The width of the riparian area ranges from 300'-700'. The riparian area was planted during the springs of 1999 and 2000 (Scott River Riparian Restoration II) and again in 2002. Management changes made the fence necessary to protect the riparian area, the stream banks and salmon redds from livestock.

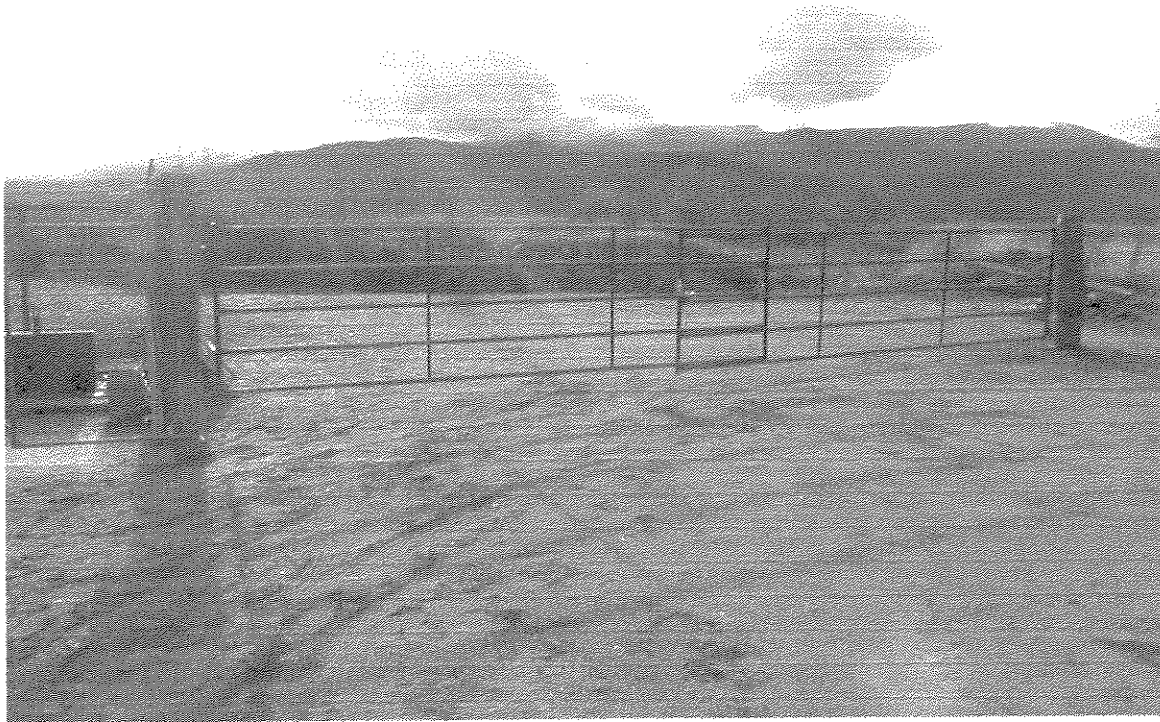
Livestock gates keeping animals off of the Scott River near Horn Lane Bridge.

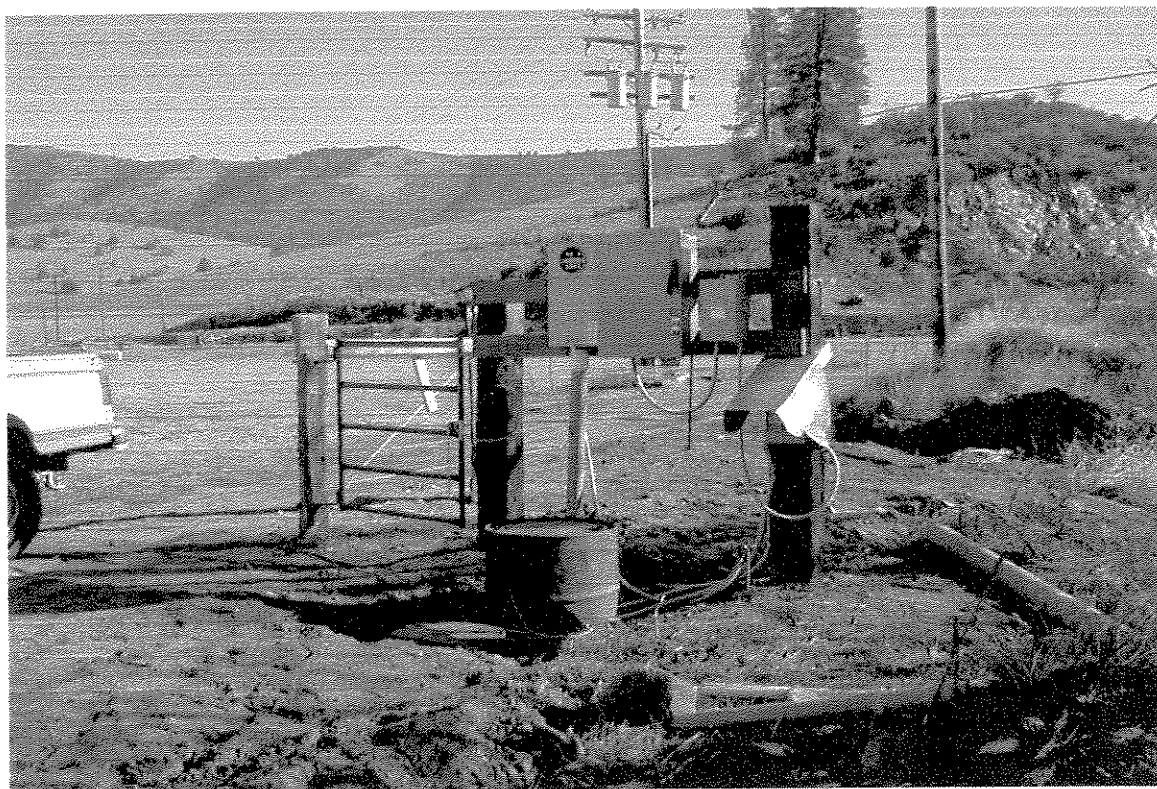
New pump system for livestock watering – Scott River near Horn Lane Bridge.

A typical alternative livestock watering system is designed and installed during the winter when stock water is plentiful and no irrigation will be taking place. The projects are designed to gain the maximum benefit for the least cost. A typical stock water system uses an existing well as its source of ground water. A small submersible pump is installed in the well casing. The pump size ranges from 3/4 to 1 1/2 horsepower depending on the number of troughs, the distance between pump and troughs and whether or not the system will double as a riparian revegetation irrigation system. A large pressure tank, pressure switch and a pressure sensor accompany the submersible pump. The system is similar in design system installed in homes. The pump system is inside an insulated pump house with a concrete foundation.
